## Fitzroy Nurseries

### Best Management Practice Growing Area Construction

# Fitzroy Nurseries BMP Growing Area Construction

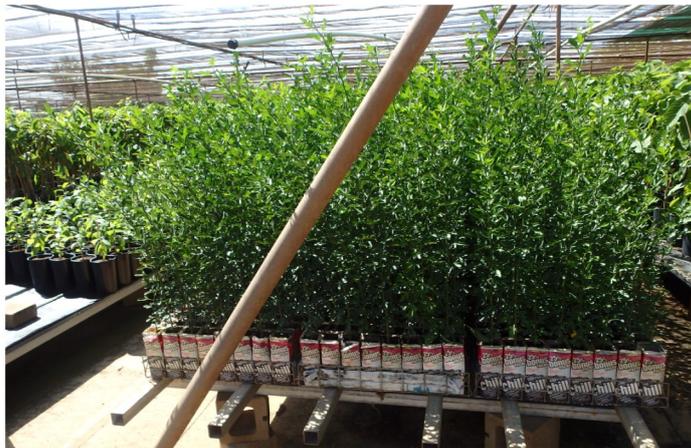
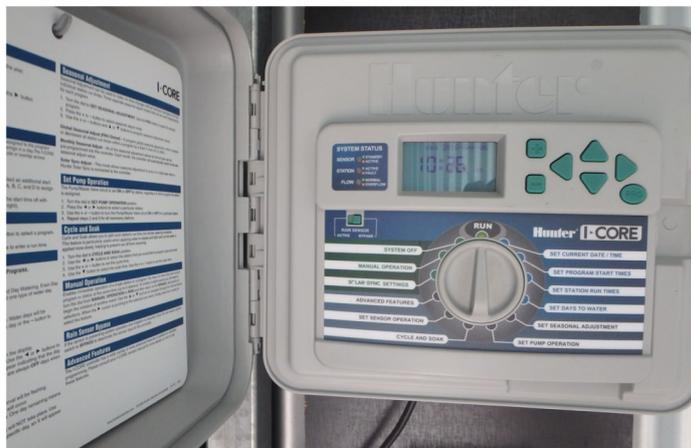
framework. However, it was decided, using the shadehouse pipe was not going to be used to also carry the irrigation water to the sprinklers. Instead, based on trials with modern sprinklers and BMP irrigation layouts conducted in other parts of the nursery, a system using Antelco Rotormax sprinklers with black jets on a 5 x 5 metre spacing, and operating at 180 kPa was used. From catch can tests conducted after installation, this layout was found to have a Mean Application Rate (MAR) of 17.1 mm/hr (BMP <15 mm/hr), a Coefficient of Uniformity (CU) of 90.1% (BMP >85%) and Scheduling Coefficient (SC) of 1.36 (BMP <1.5).

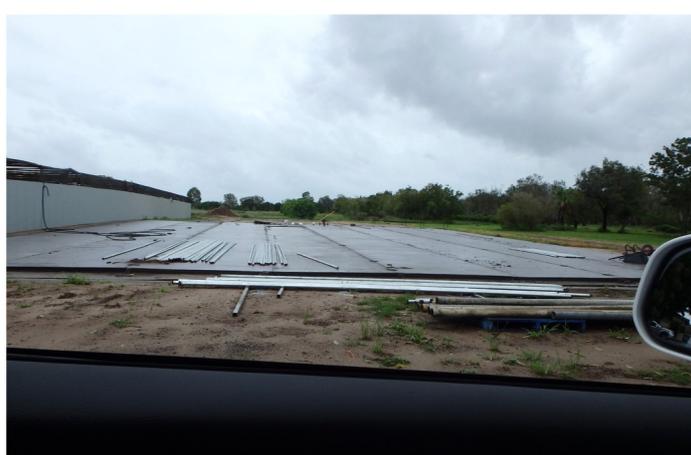
One of the selling points for Fitzroy Nurseries stock is that it is sun hardened during production, leading to better field establishment. Consequently, heavy shade is generally not used in the final stages of production, even though it may be used during propagation or early growth stages. The covering on the existing structures was a galvanised wire mesh with a poly mesh covering. To give a similar level of light exposure in the new area, a covering of black hail mesh with 30% shade factor was used.
