CARBROOK NURSERY— IRRIGATION UPGRADE

Dan Brown 13.03.2012

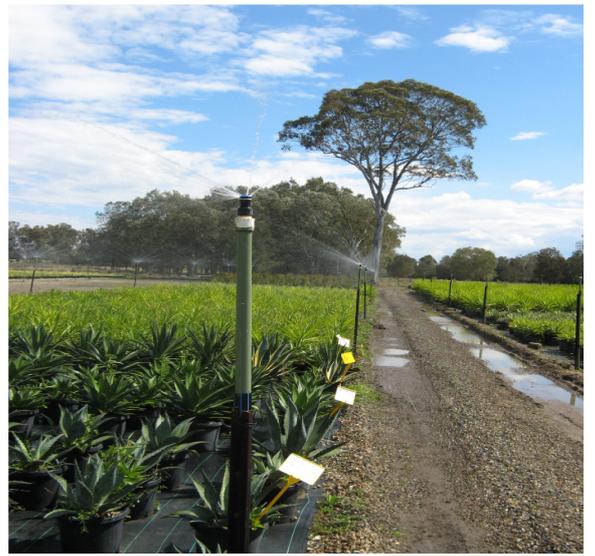
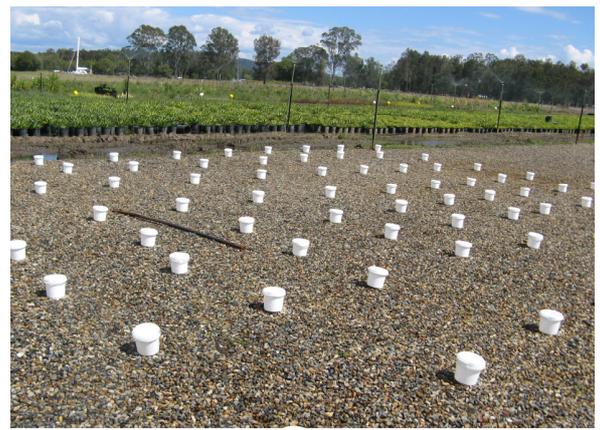
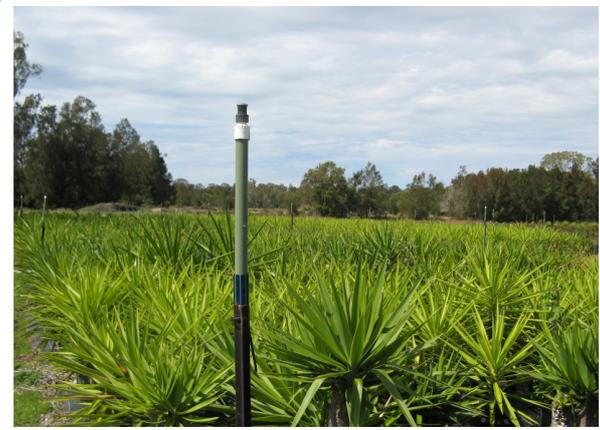
Nelson R2000 sprinklers with a K4 6° Turquoise plate and Green #14 nozzle were selected and installed at 6m x 6.5m spacing on 1.6m risers with 'road guards' located on the perimeter sprinklers and operated at 2 bar. Testing of the new sprinkler system, including growing areas affected by splash from the 'road guards' provided results that meet or exceed industry parameters (MAR 9.7mm/hr, CU 86.6% , SC 1.41) requiring 70 minutes of irrigation to provide summer (average 8mm) irrigation requirements for the new crops.

The new sprinkler system will deliver a 40% improvement in water use efficiency.

Existing sprinklers spaced at 9m x 10m were identified as inefficient and unsuitable causing compaction of the growing media, splashing of water and media from the containers onto the growing pads, and possible damage to newly planted plugs. Testing of these sprinklers (MAR 8.1mm/hr, CU 67.1%, SC 4.47) showed operation well outside nursery parameters. Calculating irrigation run times to manage the irrigation requirements of the new crops during summer (average 8mm) would require the current sprinkler system to operate for 264 minutes each day to irrigate the proposed new crop.
